**ASBESTOS MANAGEMENT
SURVEY REPORT**

S19018.1

**Canada Villa Youth Centre
Pursley Road
London, SN7 2BU**

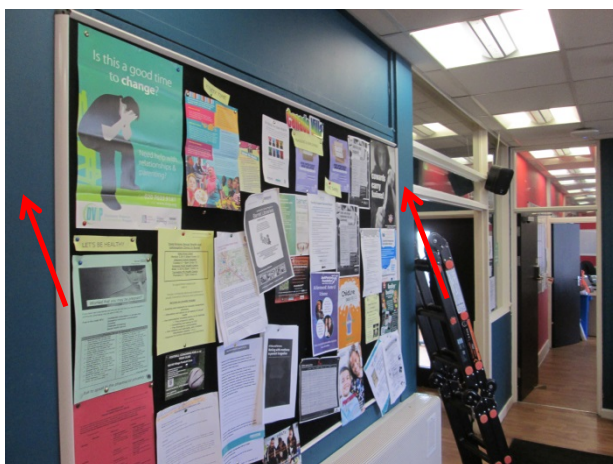
Photograph 1: G.01 Entrance Lobby – Asbestos Insulating Board (AIB) panels identified to wall, over-clad with MDF.

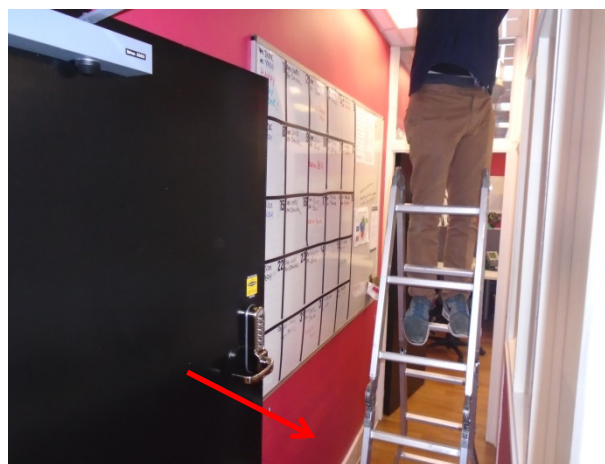
Photograph 2: G.02 Office Corridor -- Asbestos Insulating Board (AIB) infill panels previously identified below windows to G.14 Gym. Now over-clad.

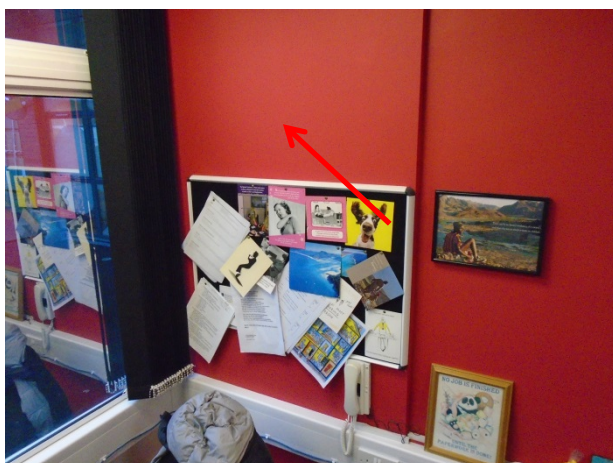
Photograph 3: G.03 Managers Office – Asbestos insulating board (AIB) infill panel previously identified to wall. Now over-clad

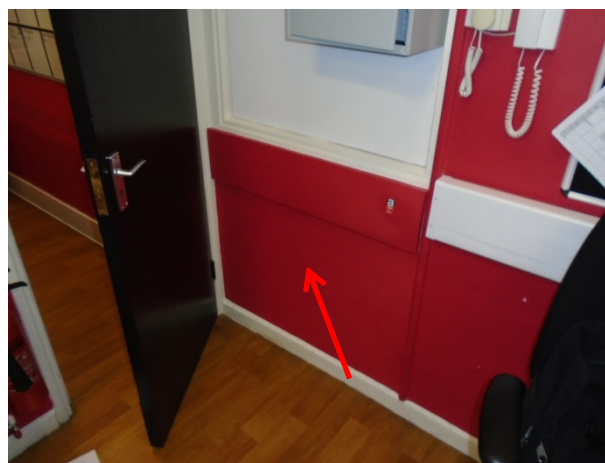
Photograph 4: G.04 Main Office – Asbestos insulating board (AIB) infill panel below window into G.14 Gym.

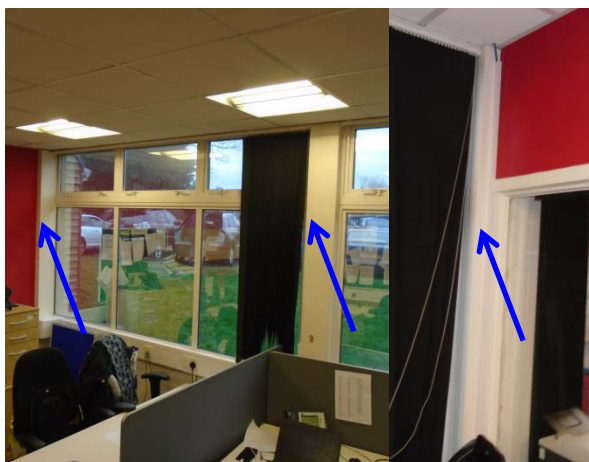
Photograph 5: G.04 Main Office – Asbestos insulating board (AIB) panels suspected beneath MDF over-cladding.

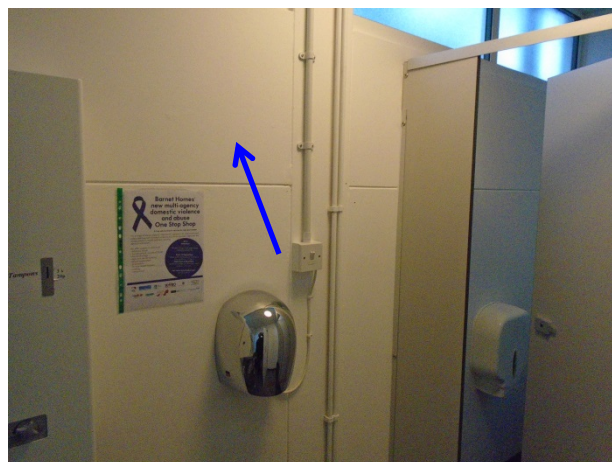
Photograph 6: G.06 Male WC and G.07 Female WC – Asbestos insulating board (AIB) wall panels previously identified. Walls now clad with MDF panelling.

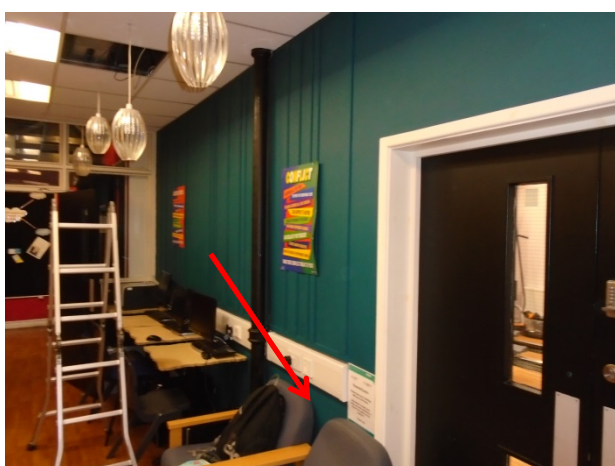
Photograph 7: G.12 Main Corridor - Asbestos insulating board (AIB) infill panels below windows to G.14 Gym (former External Courtyard).

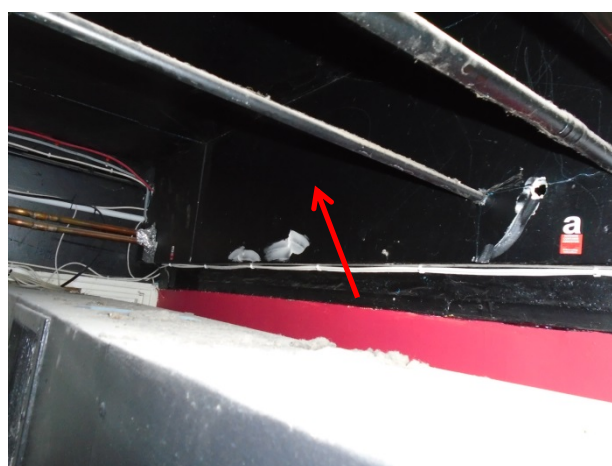
Photograph 8: G.13 Corridor – Asbestos insulating board (AIB) firebreak to high level wall between G.13 Main Corridor and G.28 Kitchen.

Recommendation: Encapsulate unpainted firebreak within G.28 Kitchen ceiling void, re-encapsulate firebreak in G.13 Corridor and G.29 Café.

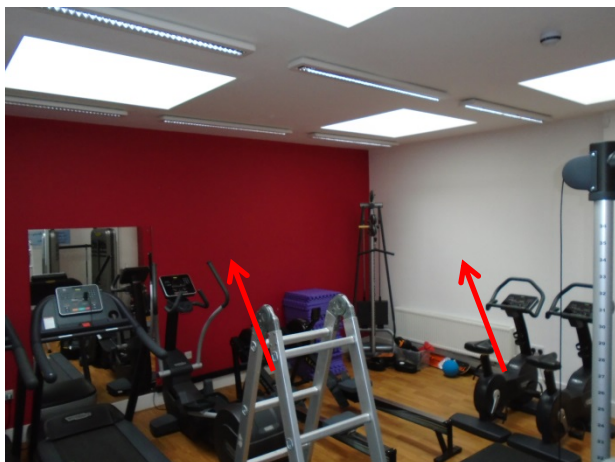
Area/Room	Sample No	Building Component	Asbestos Content	Extent	Condition	Surface Treatment	Material Assessment	Accessibility	Recommendations/Summary	Photo ID
G.12 – Main Corridor	04 M	AIB Wall Panel	Amosite	15m ²	Satisfactory condition	Enclosed	6/12	Indirect access	ASBESTOS PRESENT	7
									Monitor condition of material.	
	Asbestos insulating board (AIB) infill panel previously identified to G.14 Gym wall. Infill panels are now overlaid.									
G.13 – Corridor	04 M	AIB Firebreak Panel	Amosite	5m ²	Fair condition	Sealed	7/12	Direct access	ASBESTOS PRESENT	8
									Improvement works required.	
	High level Asbestos insulating board (AIB) firebreak panels identified between corridor and G.28 Kitchen, firebreak has been drilled into and has sustained light damage, re-encapsulation works are recommended.									
G.14 – Gym	04 M	AIB Wall Panel	Amosite	60m ²	Satisfactory condition	Enclosed	6/12	Indirect access	ASBESTOS PRESENT	9

Monitor condition of material.	
	Asbestos insulating board(AIB) infill panels previously identified to all four walls of room; room has been refurbished and plasterboard walls are now present. AIB infill panels are expected to remain below overcladding. No inspection of the ceiling void has taken place as ceiling is a dropped plasterboard construction.									
G.15 – Shower									LOCATION INSPECTED; NO ASBESTOS IDENTIFIED	
Shower room inspected, no asbestos containing materials materials (ACMs) identified; limited inspection of the ceiling void via a small access hatch.										
G.16 – Safe Storage	05 M	AIB Wall Panel	Amosite	7m ²	Satisfactory condition	Enclosed	6/12	Indirect access	ASBESTOS PRESENT	10
									Monitor condition of material.	
	Asbestos insulating board(AIB) infill panels previously identified to G.14 Gym wall; AIB panels are presumed to remain below overcladding.

Photograph 9: G.14 Gym – Asbestos insulating board (AIB) panelling to low level window positions behind plasterboard wall lining.

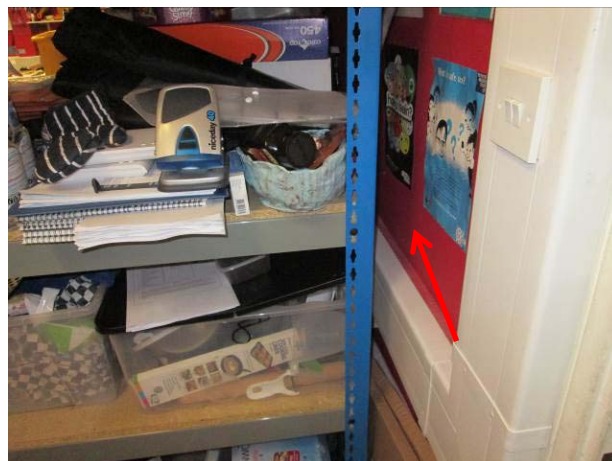
Photograph 10: G.16 Safe Storage – Asbestos insulating board (AIB) infill panels to lower level window positions to G.14 Gym (former External Courtyard). Panels now over-clad.

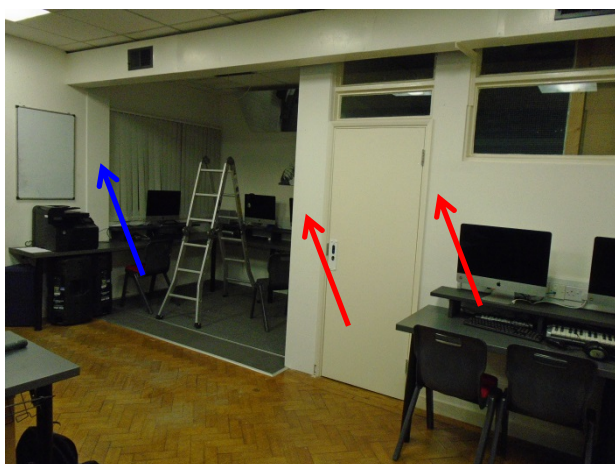
Photograph 11: G.18 Rithmik Music Studio – Asbestos Insulating Board (AIB) panels identified to wall, over-clad with MDF.

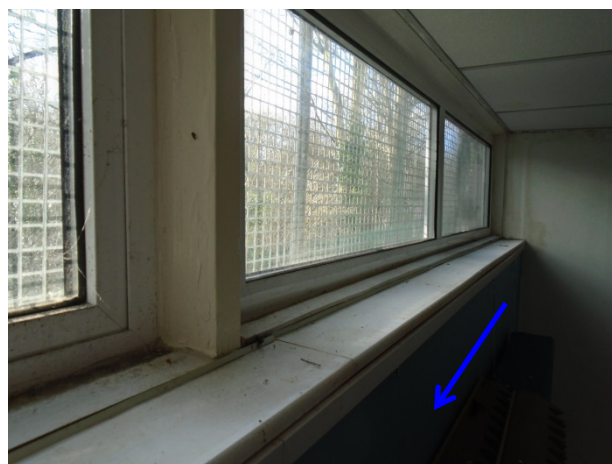
G.19 – Radio Booth		Wall Panel					SUSPECT		ASBESTOS SUSPECTED	12
									High presumption of the presence of asbestos materials. Programme further investigation.	
Asbestos insulating board wall panels previously identified to external wall. Internal walls now MDF, no evidence of removal works provided at time of inspection. AIB panels presumed to remain to wall. Further investigation works are recommended prior to any refurbishment works within area.										
G.20 – Control Booth		Wall Panel					SUSPECT		ASBESTOS SUSPECTED	12
									High presumption of the presence of asbestos materials. Programme further investigation.	
Asbestos insulating board wall panels previously identified to external wall. Internal walls now MDF, no evidence of removal works provided at time of inspection. AIB panels presumed to remain to wall. Further investigation works are recommended prior to any refurbishment works within area.

Photograph 12: G.19 Radio Booth – Asbestos insulating board (AIB) infill panels are suspected to be present to the external facing wall behind plasterboard.

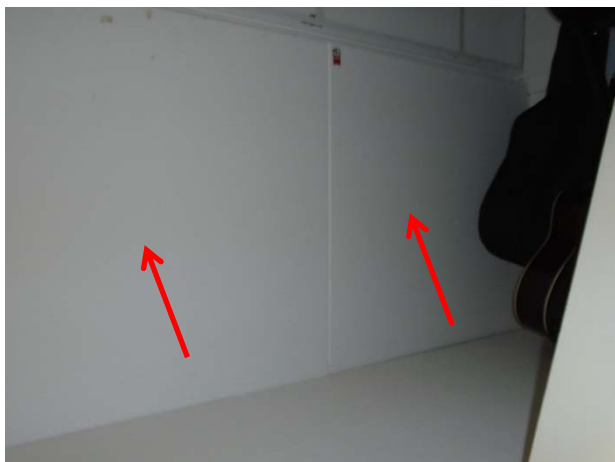
Photograph 13: G.22 Small Teaching Room – Asbestos insulating board (AIB) ceiling panels.

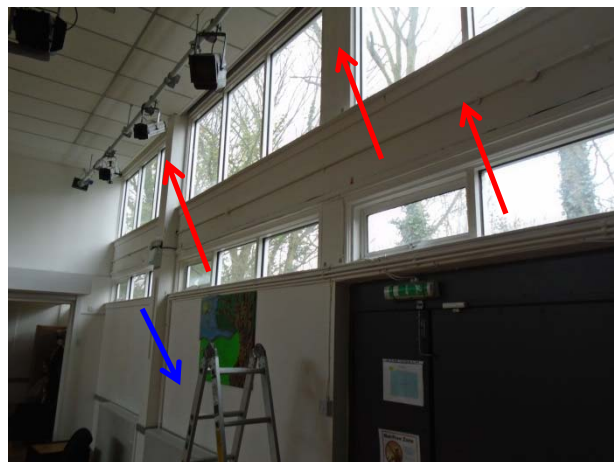
04 A	AIB Wall Panel	Amosite	6m ²	Satisfactory condition	Sealed	6/12	Direct access	ASBESTOS PRESENT	14
------	----------------	---------	-----------------	------------------------	--------	------	---------------	-------------------------	----

Photograph 14: G.24 Main Hall – Asbestos insulating board (AIB) wall panels below window positions to external wall. Asbestos insulating board (AIB) inset panels to walls.

Monitor condition of material.

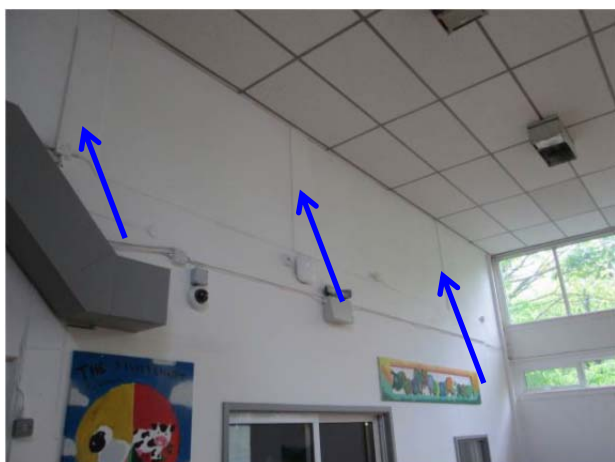
05 A	AIB Cladding	Amosite	24m ²	Satisfactory condition	Sealed	6/12	Direct access	ASBESTOS PRESENT	14, 15, 16
------	--------------	---------	------------------	------------------------	--------	------	---------------	-------------------------	------------

Photograph 15: G.24 Main Hall – Asbestos insulating board (AIB) inset panels to wall previously identified, now covered over by a mezzanine level extension; no evidence of removal works supplied at time of inspection, presumed to remain behind modern extension.

Monitor condition of material.

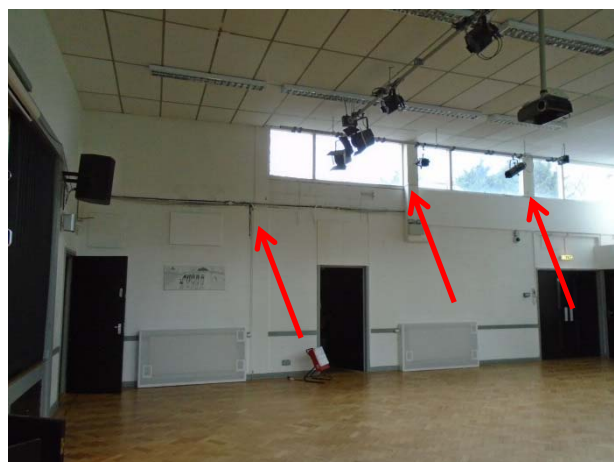
Photograph 16: G.24 Main Hall – Asbestos insulating board (AIB) inset panels to wall.

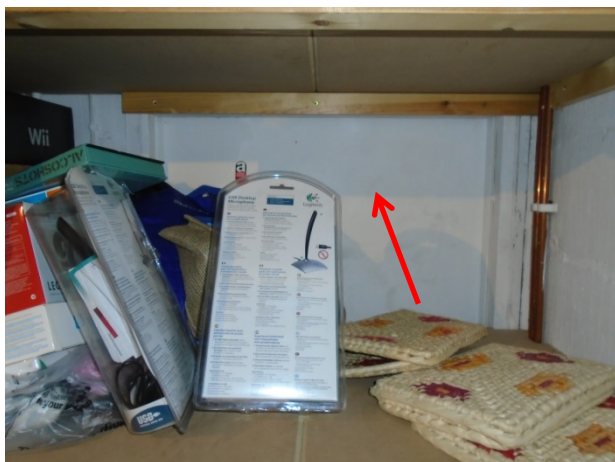
Photograph 17: G.27 'D of E' Store – Asbestos insulating board (AIB) door header panel above sealed doorway and timber infill.

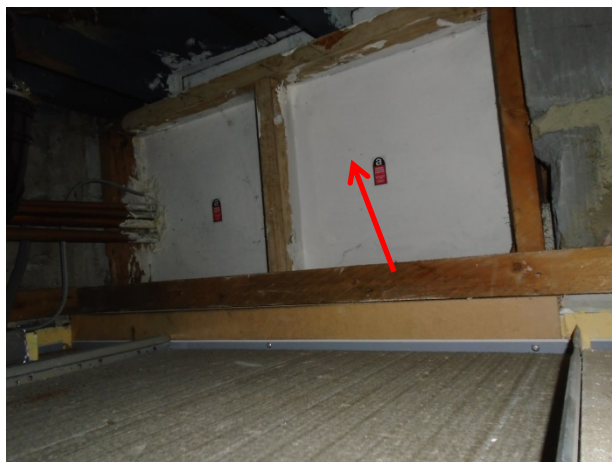
Asbestos insulating board (AIB) debris suspected within high level timber boxing. No internal inspection at time of survey.											
	07 M	AIB Panel	Amosite Chrysotile	1m²	Fair condition	Sealed	8/12	Direct access	ASBESTOS PRESENT	18	
								Monitor condition of material.			
Asbestos insulating board (AIB) door header panel identified above blocked doorway to G.27 D of E Kitchen.											
G.29 – Café	04 M	AIB Wall Panel	Amosite	24m²	Satisfactory condition	Sealed	6/12	Direct access	ASBESTOS PRESENT	22, 23	
									Monitor condition of material.		
	Asbestos insulating board (AIB) wall panelling identified to wall adjacent to G.14 Gym.										
	04 M	AIB Firebreak Panel	Amosite	3m²	Fair condition	Sealed	7/12	Direct access	ASBESTOS PRESENT	20	
								Improvement works required.			
Asbestos insulation board (AIB) firebreak panel identified to high level wall to G.28 Kitchen, firebreak has previously been drilled through and lightly damaged. Re-encapsulation works are recommended.

Photograph 18: G.28 Kitchen – Asbestos insulating board (AIB) door header panel within ceiling void.

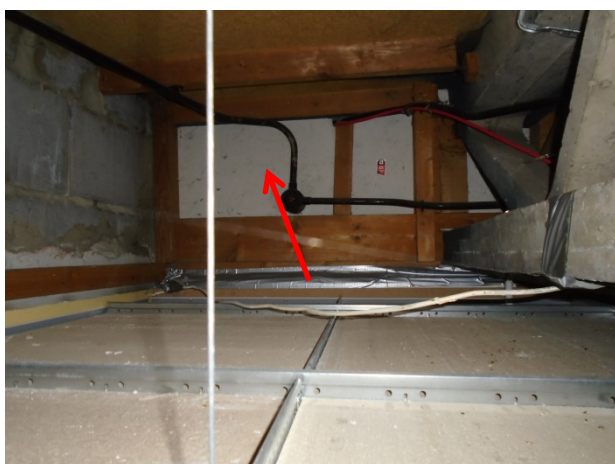
Photograph 19: G.28 Kitchen – Asbestos insulating board (AIB) fire break between G.13 Corridor and G.29 Café.

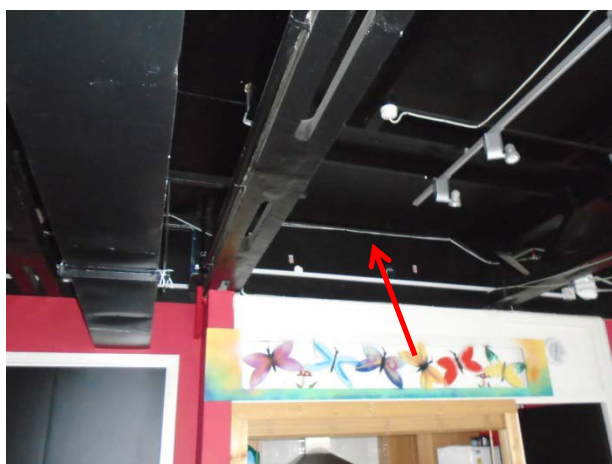
Photograph 20: G.29 Café - Asbestos insulating board firebreak to G.28 Kitchen ceiling void.

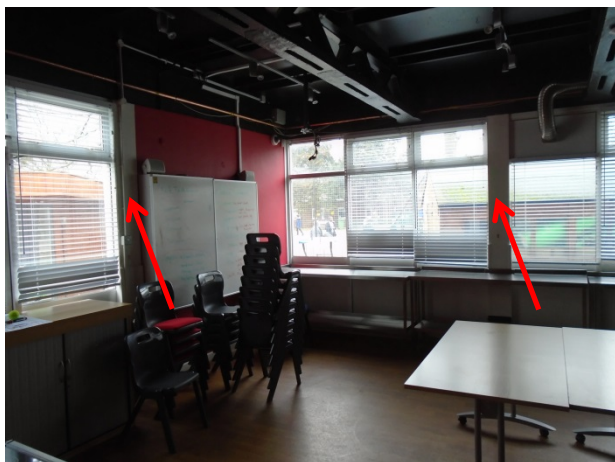
Area/Room	Sample No	Building Component	Asbestos Content	Extent	Condition	Surface Treatment	Material Assessment	Accessibility	Recommendations/Summary	Photo ID
G.29 – Café	05 M	AIB Cladding	Amosite	9m ²	Satisfactory condition	Enclosed	6/12	Indirect access	ASBESTOS PRESENT	21

Photograph 21: G.29 Café - Asbestos insulating board cladding to metal columns, AIB over-clad with MDF.

Monitor condition of material.

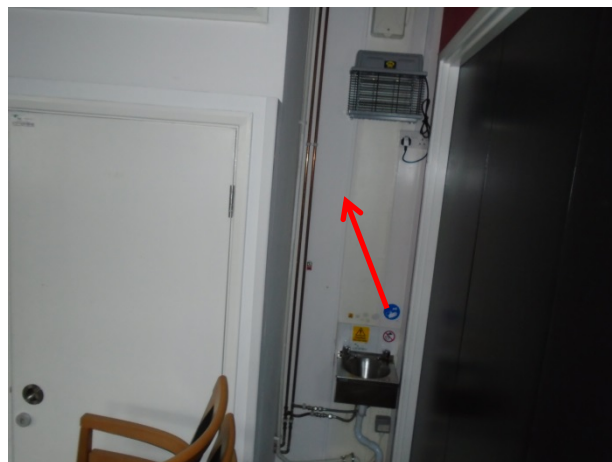
Photograph 22: G.29 Café – Asbestos insulating wall panelling to G.14 Gym wall present behind modern cooker units.

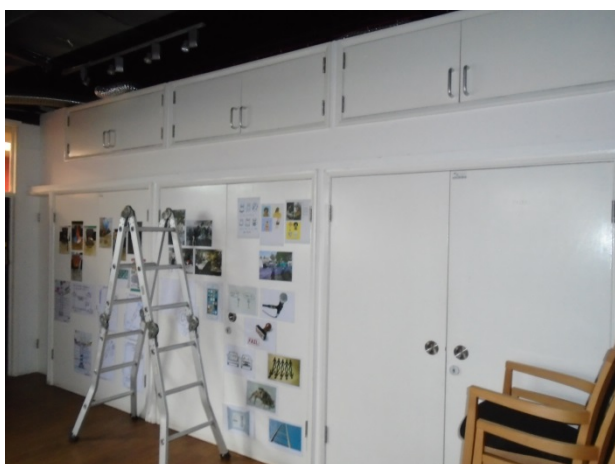
Photograph 23: G.29 Café – Asbestos insulating wall panelling to G.14 Gym wall present behind modern cooker units.

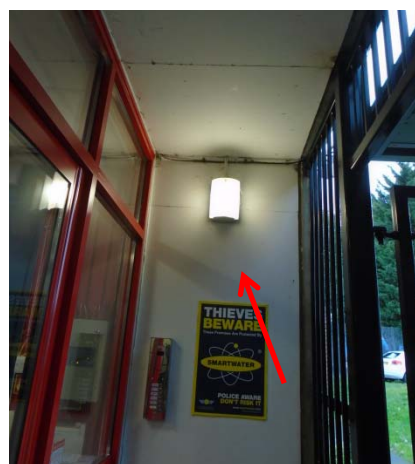
Photograph 24: External – EX.01 Entrance canopy – Asbestos insulating board previously identified to G.03 Managers Office behind MDF over-cladding.
